# REPORT INTERTEK, ETL SEMKO

**3080447CRT-001**

Report Scope: Performance testing of an in-duct air purification system

Sample Description: One Bentax In-Duct air cleaner Model 500F installed in a commercial application, and one Bentax In-Duct air cleaner Model 100D installed in a residential application.

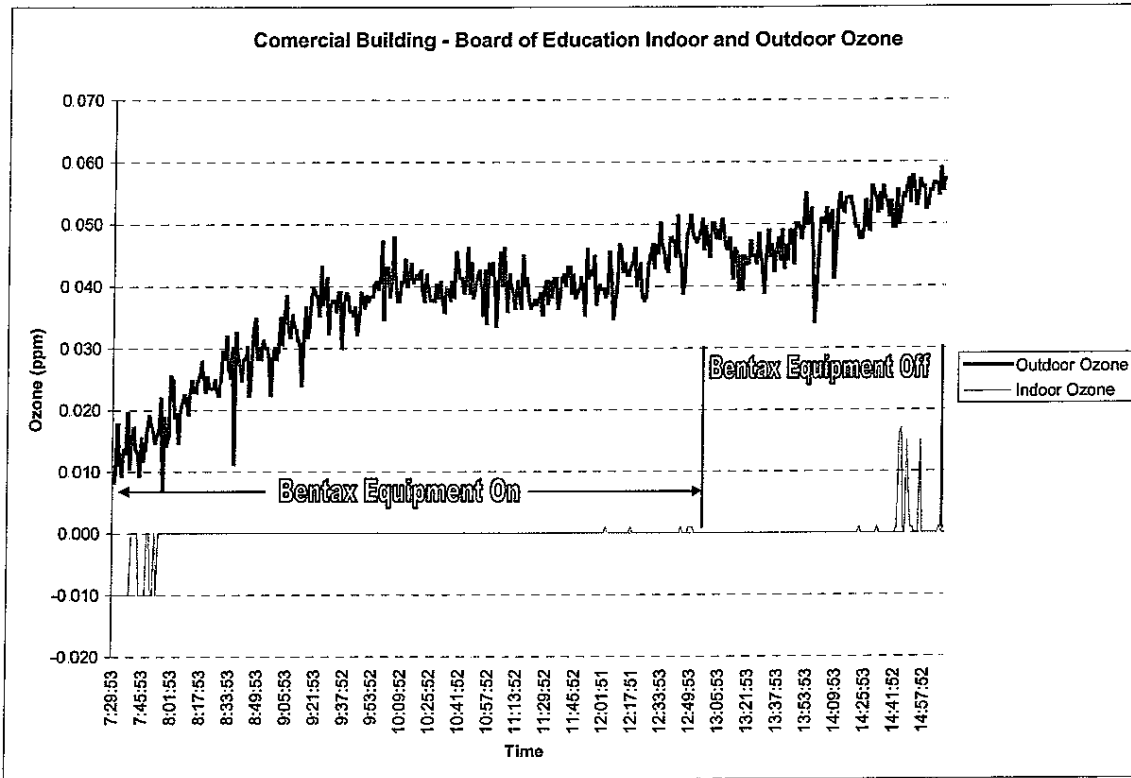
Appendix A

After approximately 5½ hours of data sampling, the average ozone reading inside the building was 0.000 PPM with the outside ozone levels ranging between 0.01 PPM and 0.05 PPM. After the equipment was de-energized, spikes in inside ozone levels were recorded. When the equipment was re-energized, the spikes in inside ozone ceased and readings went back down to 0.000 PPM. Detailed results are shown in Appendix A, which is attached to, and forms part of, this report.

- a) Two ozone monitors and one ion meter were set-up and started sampling at approximately 7:30am on July 14, 2005. One ozone monitor was used to measure indoor ozone, and one ozone monitor was used to measure outdoor ozone.
- b) The Bentax In-duct air cleaner was operating throughout the tests, but was purposely de-energized at approximately 12:55 pm on July 14, 2005, and the ozone monitors continued to log data.
- c) At approximately 2:40pm, on July 14, 2005, spikes in ozone were noticed on the indoor ozone analyzer. Ozone levels were not logged, but were physically recorded between 0.015 and 0.017.
- d) The Bentax In-duct air cleaner was re-energized at approximately 2:40pm, on July 14, 2005.

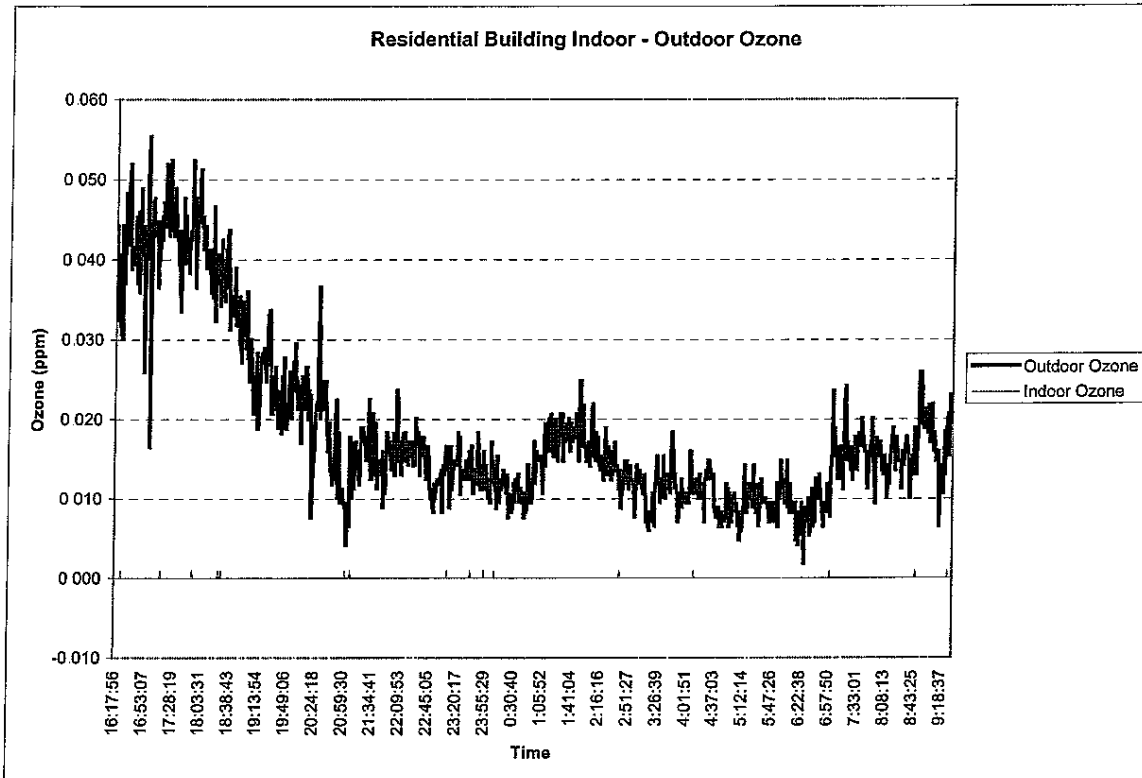
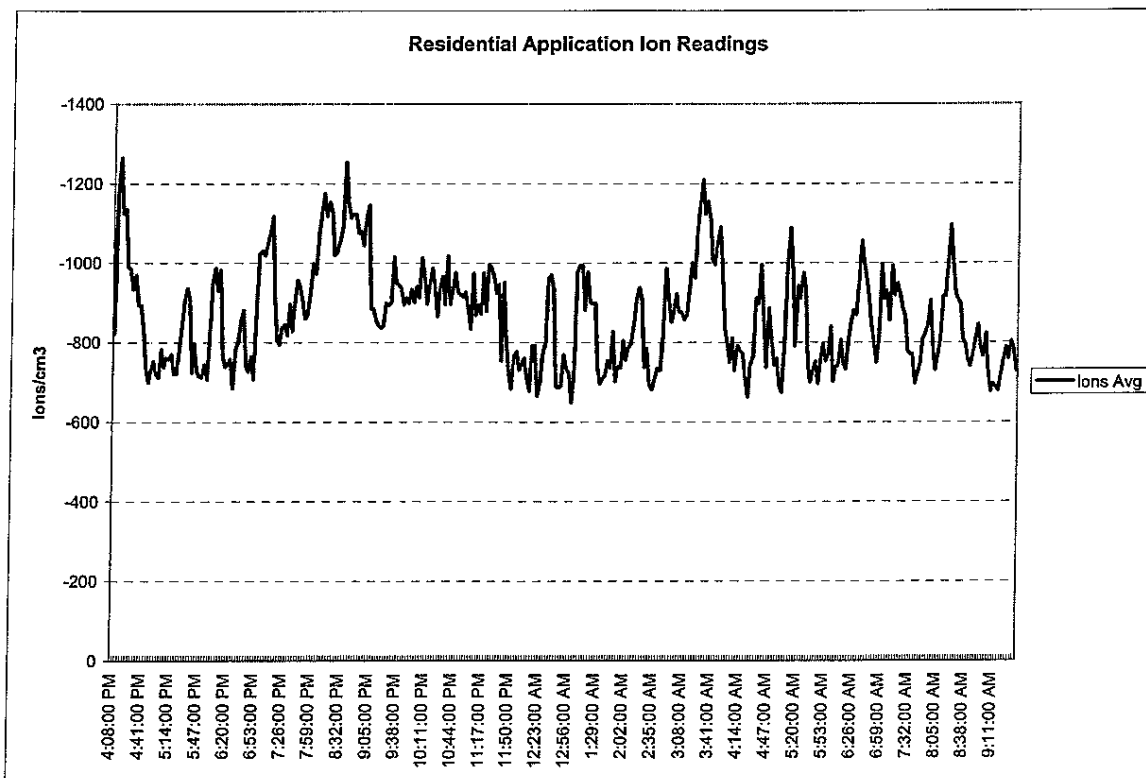
Appendix B

After approximately 17 hours of data sampling, the average ozone reading inside the residence was 0.000 PPM with the outside ozone levels ranging between 0.00 PPM and 0.055 PPM. Detailed results are shown in Appendix B, which is attached to, and forms part of, this report.

- a.) Two ozone monitors and one ion meter were set-up and started sampling at approximately 4:17pm on July 14, 2005. One ozone monitor was used to measure indoor ozone, and one ozone monitor was used to measure outdoor ozone.
- b.) At approximately 9:32am on July 15, 2005, the test was ended.
